# Manhole Inspection Summary

Manhole # S2111\_010MH

Insp Date: **5/7/08 11:23 AM**

**Location** Address: **2614 stranden rd**

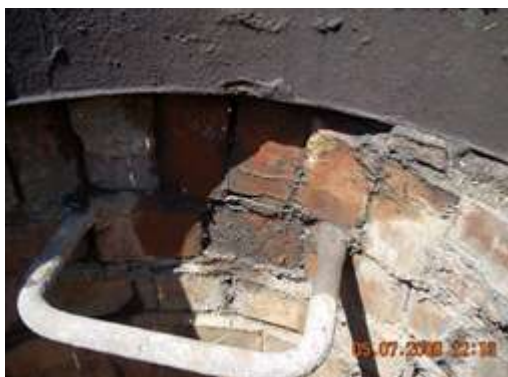
Defect 4

Infiltration: ☐ None ☒ **Joint** ☐ Cracks ☐ Mortar ☐ Roots ☐ Wall

infiltration @ chimney/frame joint

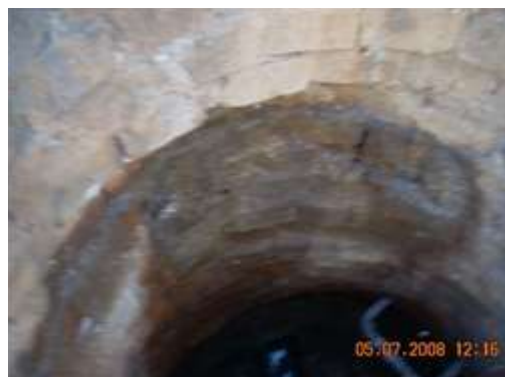
Defect 3

Infiltration: ☐ None ☐ Joint ☐ Cracks ☐ Mortar ☐ Roots ☒ **Wall**

infiltration from corbel deterioration

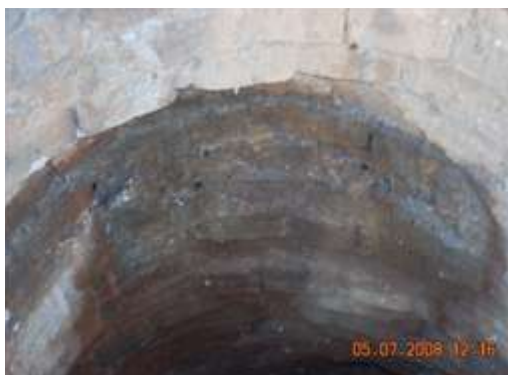
Defect 2

Condition: ☐ Sound ☐ Cracked ☐ Root Intrusion ☐ Loose Brick ☒ **Deteriorated**

deteriorated corbel bricks

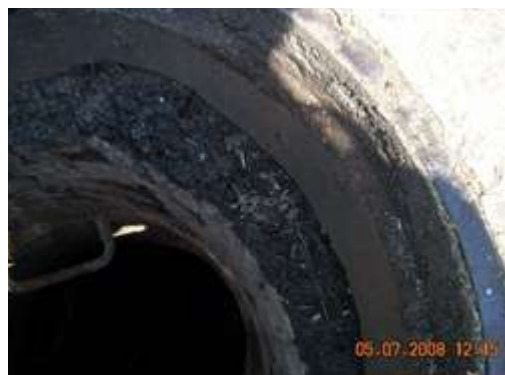
Defect 1

**Frame** Offset: **3** (in.) Condition: ☒ Sound ☐ Cracked ☐ Leaks

frame offset

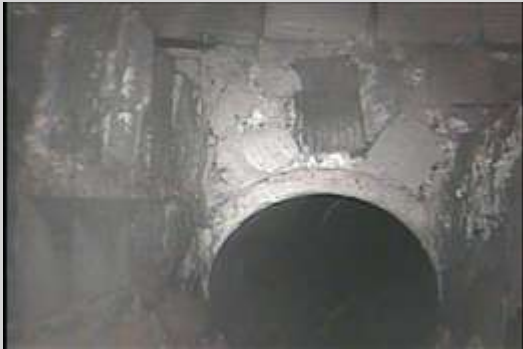
12 O'Clock Outflow

Pipe Height: **8.4** (in.) Rod and Bar (Angled)  
Pipe Material: **Clay** ☐ Pipe Lined  
Invert Depth: **10.42** (ft.) Flow Characteristics: **Slow**  
Deposits: ☒ None ☐ Mud ☐ Sludge ☐ Debris ☐ Grease  
Silt Depth: **0** (in.) Deposits Extent:  
Infiltration: **None** Pipe Seal Cond: **Sound**

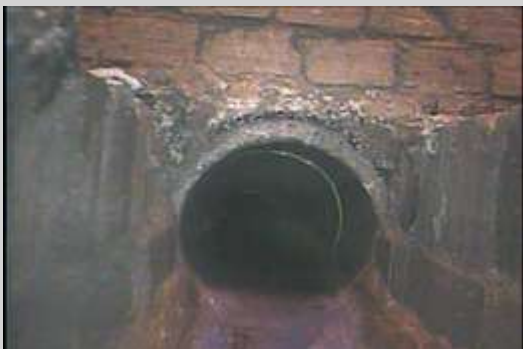
6 O'Clock Inflow

Pipe Height: **8.4** (in.) Rod and Bar (Angled)  
Pipe Material: **Clay** ☐ Pipe Lined  
Invert Depth: **10.00** (ft.) Flow Characteristics: **Slow**  
Deposits: ☒ None ☐ Mud ☐ Sludge ☐ Debris ☐ Grease  
Silt Depth: **0** (in.) Deposits Extent:  
Infiltration: **None** Pipe Seal Cond: **Sound**
